# Manhole Inspection Summary

Manhole # S37E\_\_037MH

Insp Date: **1/23/09 12:21 PM**

**Location** Address: **234 holiday st**

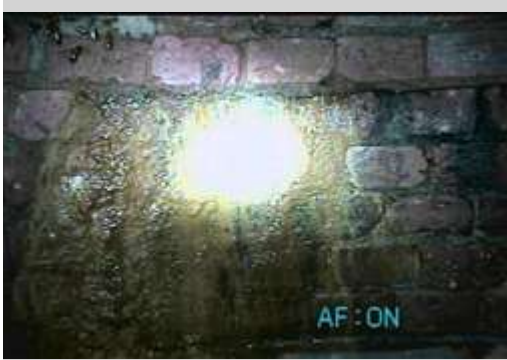
Defect 3

Infiltration: ☐ None ☐ Joint ☐ Cracks ☐ Mortar ☐ Roots ☒ **Wall**

infiltration in wall of barrel

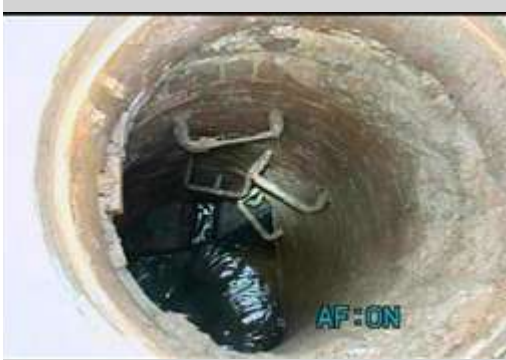
Defect 2

Count: **5** Missing: **0** ☒ **Corroded**

steps

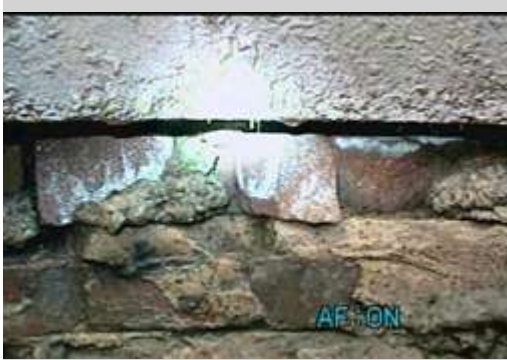
Defect 1

Condition: ☐ Sound ☐ Cracked ☐ Root Intrusion ☒ **Loose Brick** ☒ **Deteriorated**

frame adj

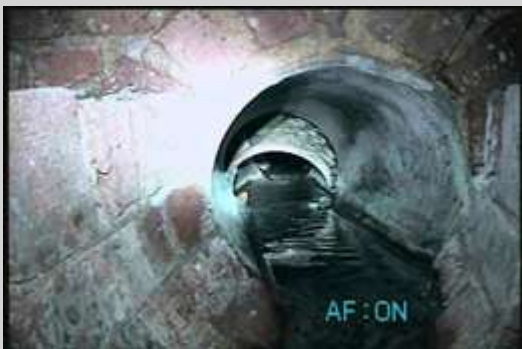
3 O'Clock Inflow

seems to be an offset joint in the pipe
